On-grid Solar PV Systems at Four Public Hospitals in Lebanon

Solar for Health (S4H)

under the kWf KfW Bankengruppe funded Solar for Health project' implemented by Earth Technologies

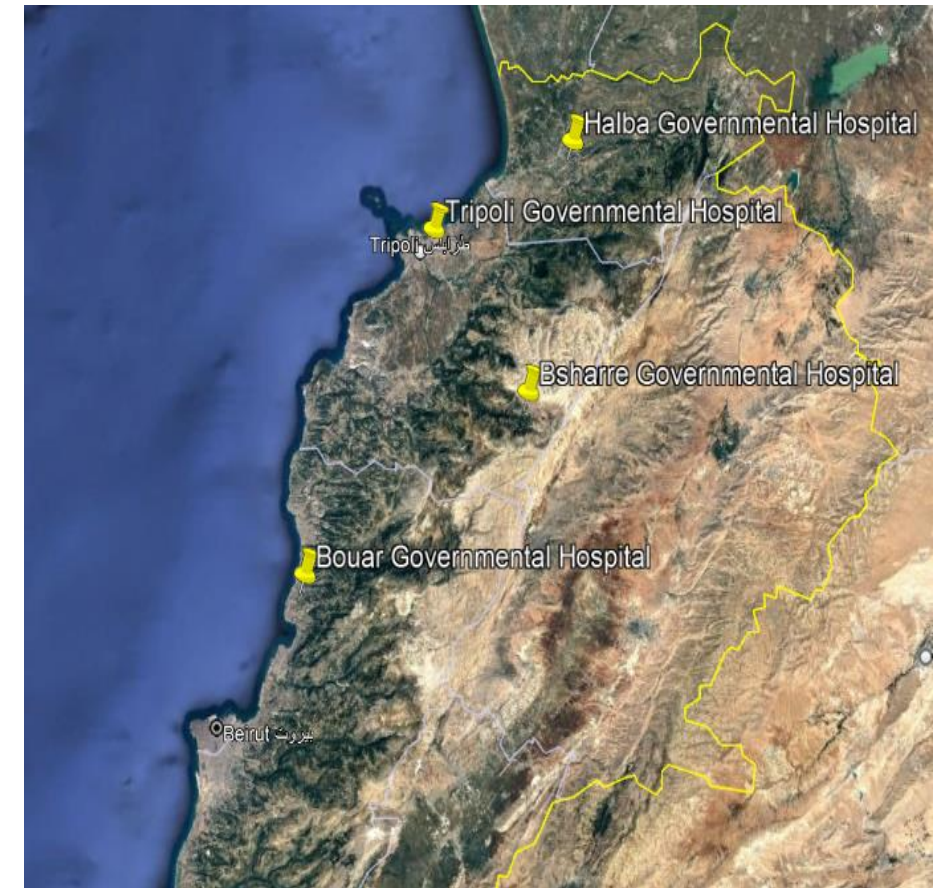
Halba Hospital

- PV size: 93.62 kWp
- Number of panels: 175
- Mounting structure: Carport
- On-grid inverters: 4 units
SMA STP25000TL

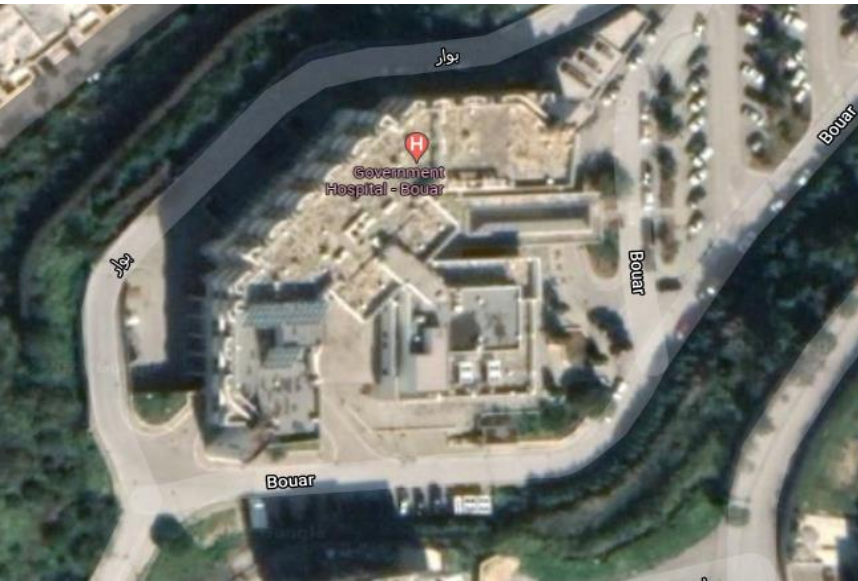
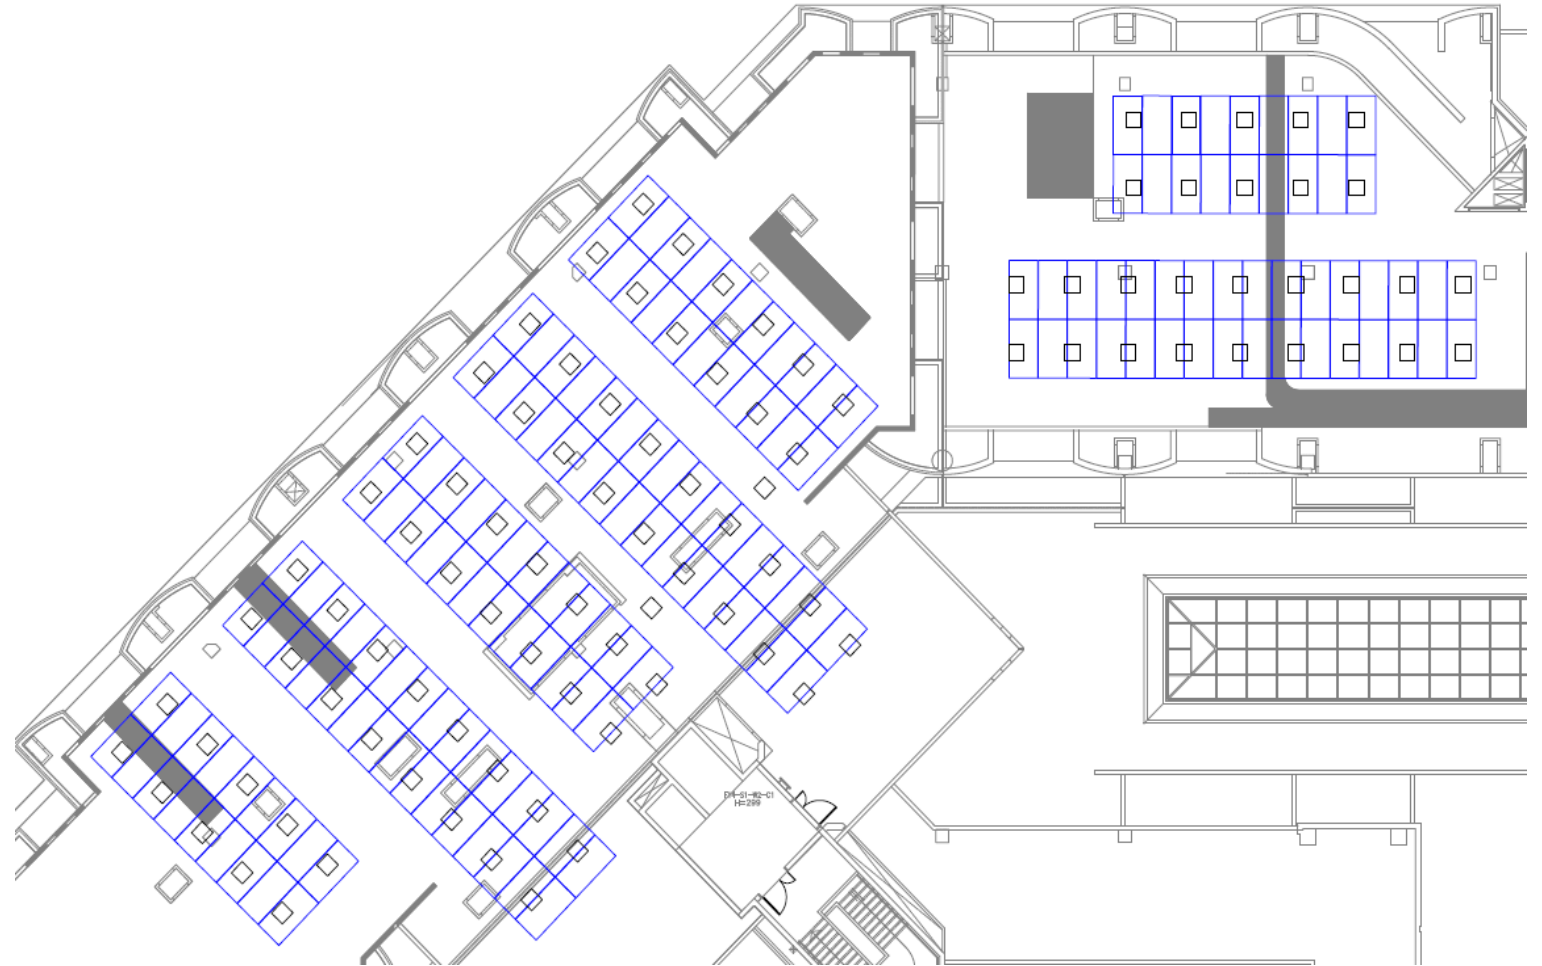
Bouar Hospital

- PV size: 94.16 kWp
- Number of panels: 176
- Mounting structure: Elevated structure on roof
- On-grid inverters: 4 units
SMA STP25000TL

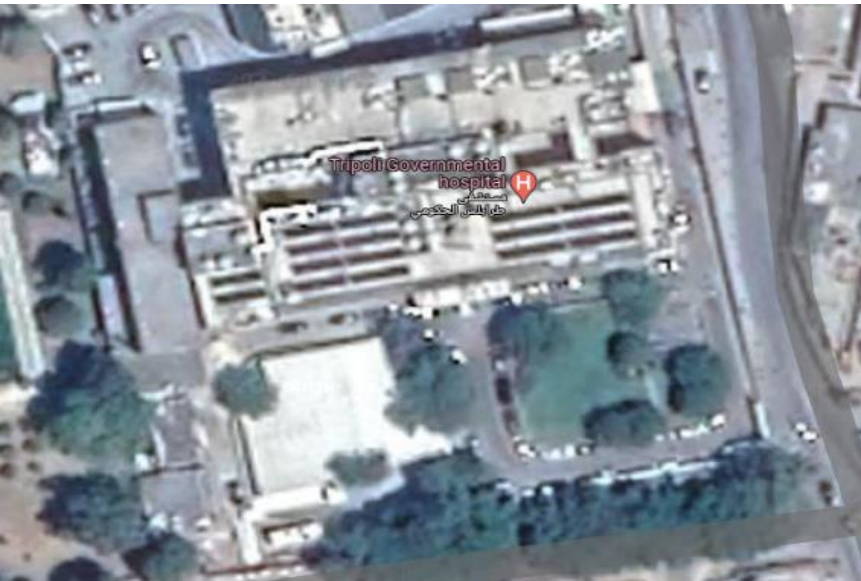
Tripoli Hospital

- PV size: 67.41 kWp
- Number of panels: 126
- Mounting Structure: aluminum structure fixed on curbstones and direct bolting on peripheral parapet
- On-grid inverters: 3 units SMA STP25000TL

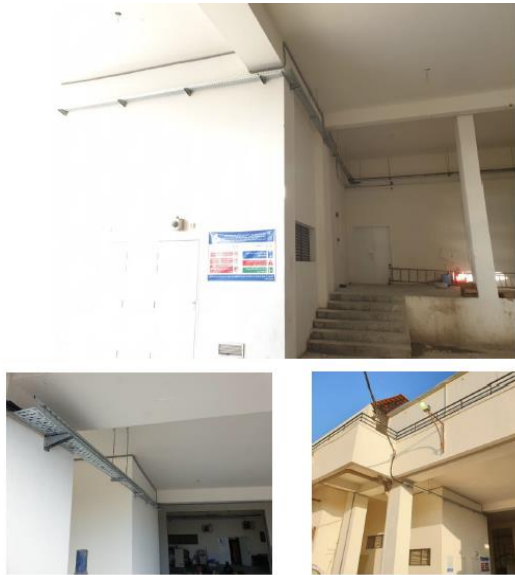
Halba

- 75% of Electrical Works were completed in Halba, Bsharre, Tripoli and Bouar Hospitals

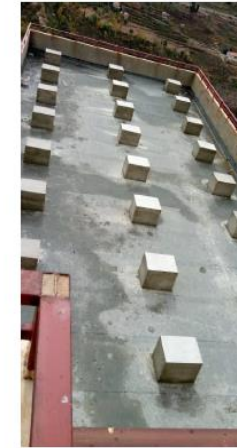
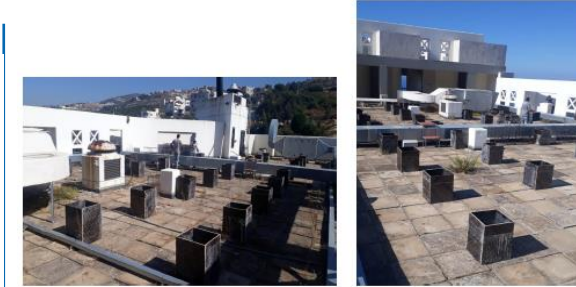
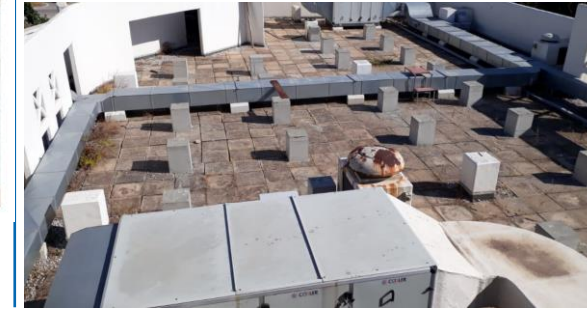
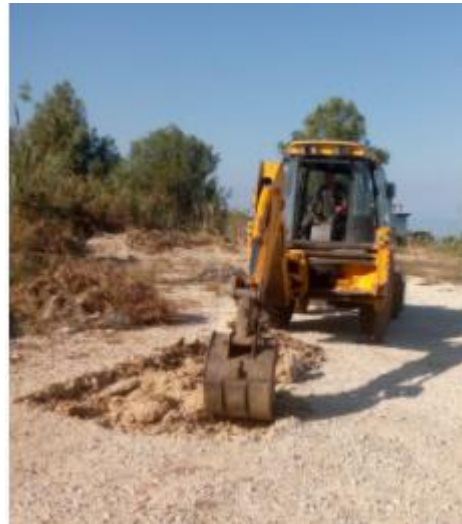
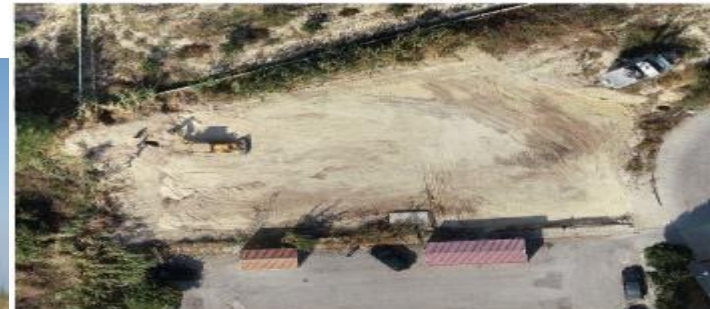
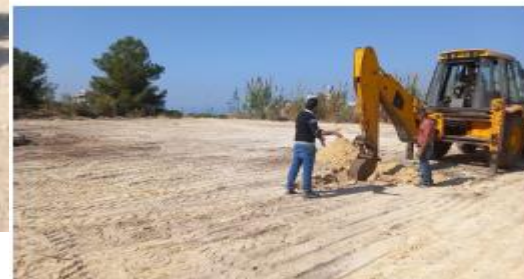
- 75% of Civil Works were completed in Halba, Bsharre, Tripoli and Bouar Hospitals
- In Halba, the land turned out to be unsuitable for the structure installation (landfill), additional works are being taken to be able to install the carport

In places where PV support structure is required to be elevated and to support high wind loads (140km/h) a profound structural and soil analysis should be performed beforehand to make sure the existing area where the structure will be installed can withstand the load
